# WEST CITY

April 2024

**FINDING  
OF  
NECESSITY**

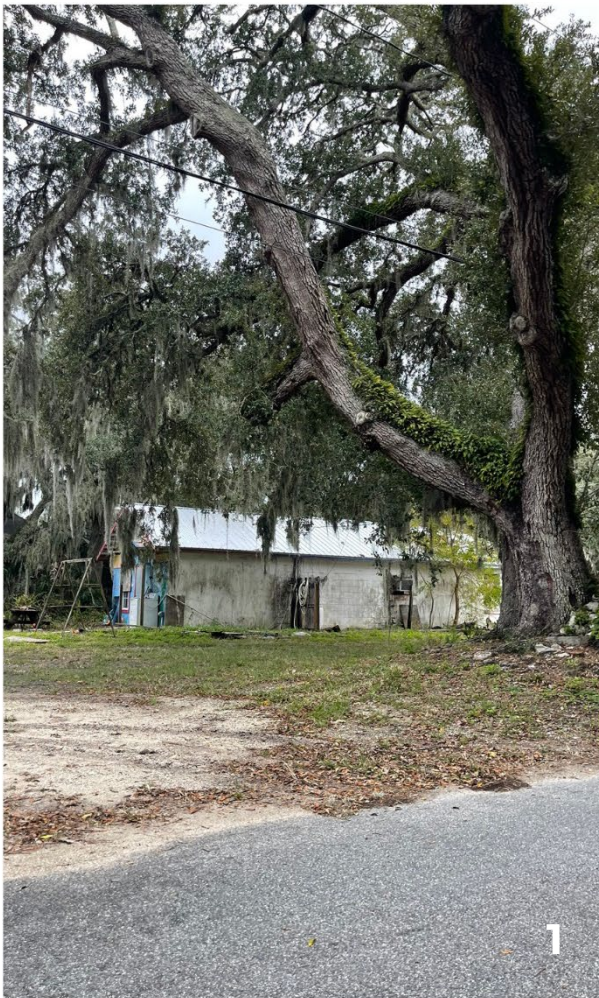
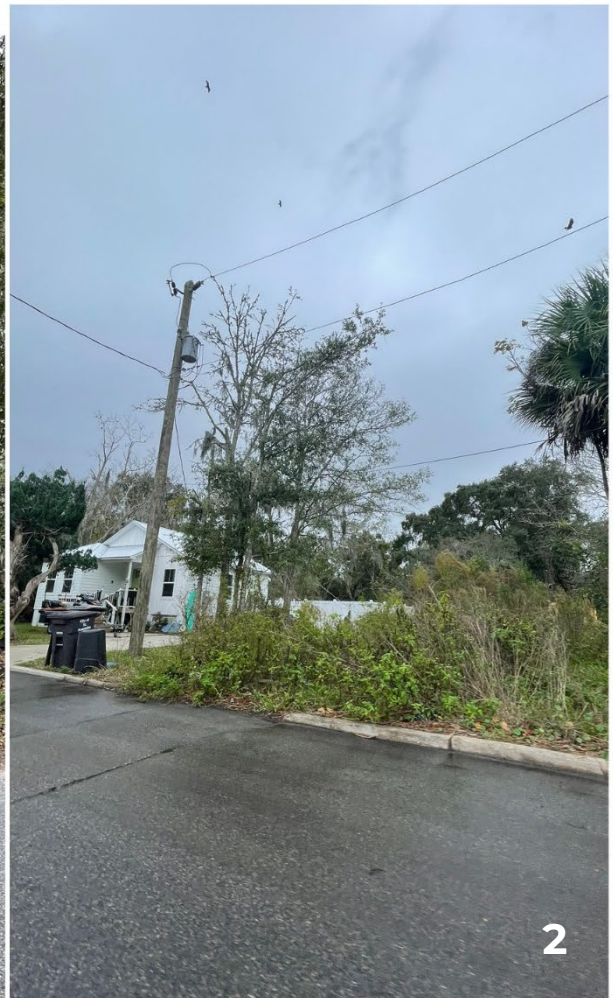
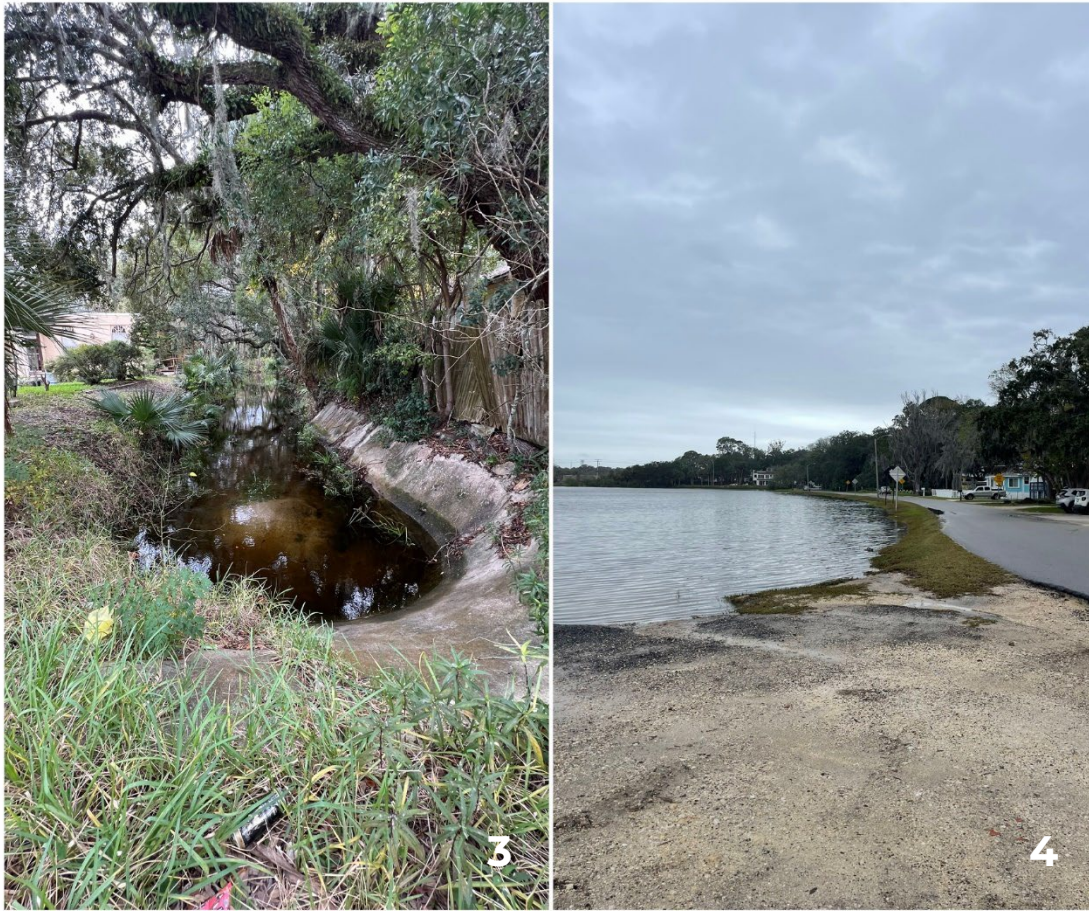
In portions of the Study Area, there are conditions which endanger life by means of fire or flooding. Overgrown vegetation, especially when near overhead powerlines or other power sources, pose fire risks to surrounding properties. Without regular maintenance to the vegetation, generally in right-of-way or greenbelt areas, lightning or downed powerlines could easily cause a fire that can easily spread. Stormwater drainage areas and waterways can cause flooding, risk to properties, and risk to human life. Along Lewis Boulevard, Oyster Creek flows into San Sebastian River. At this confluence, the creek flows very closely to neighboring roadways (US-1, Lewis Boulevard, and Rio Vista Drive). During heavy rains, these roadways are at risk of flooding, as are neighboring residential and commercial properties.

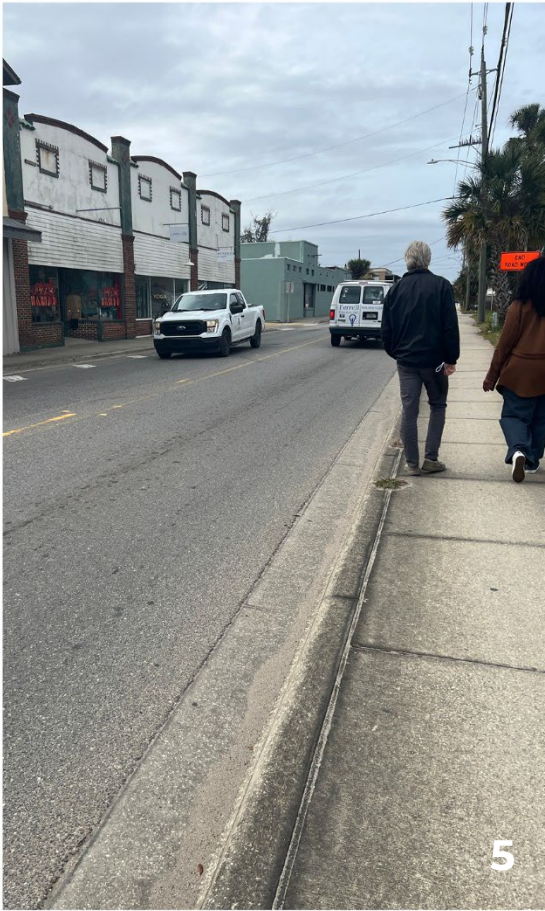
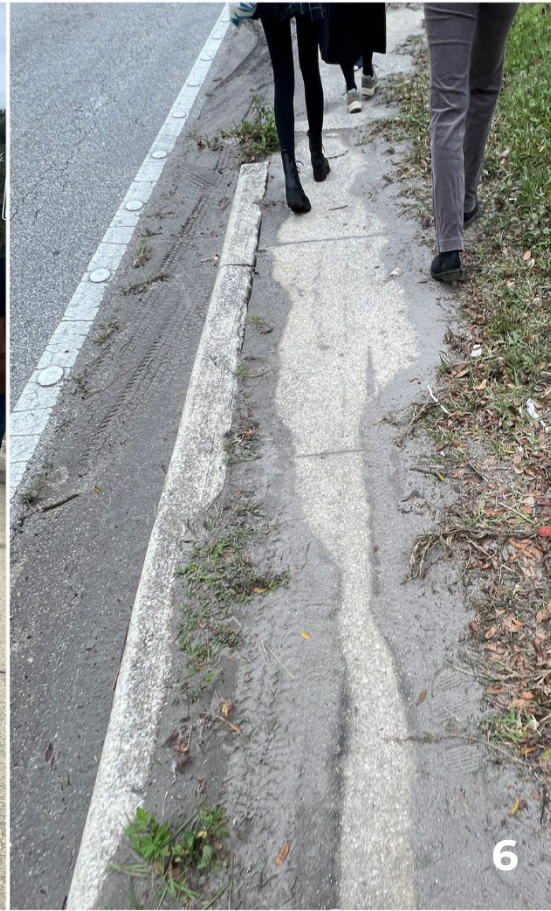
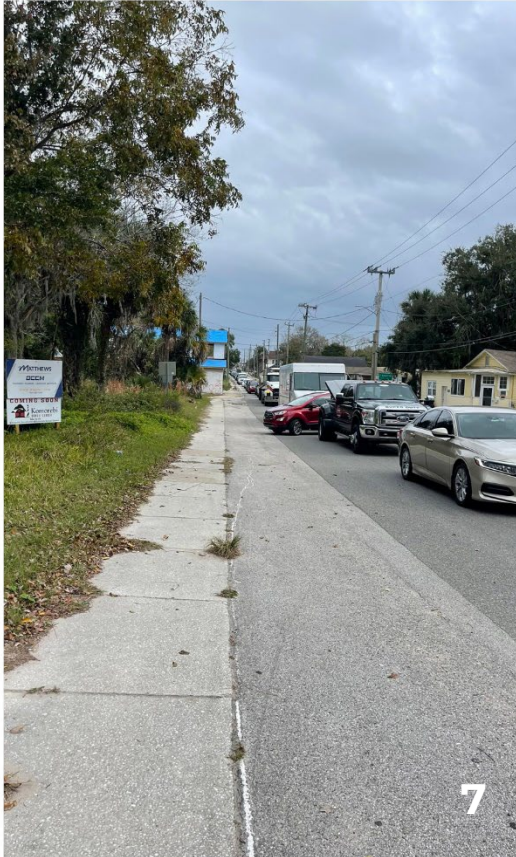
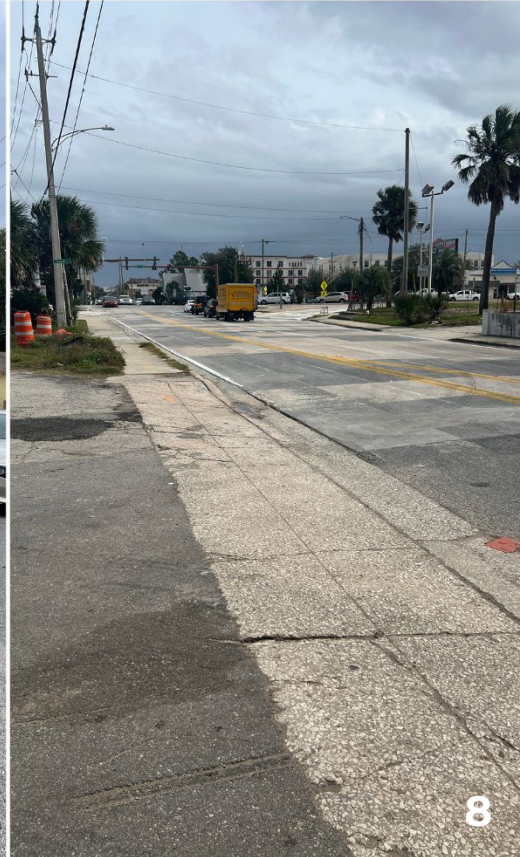
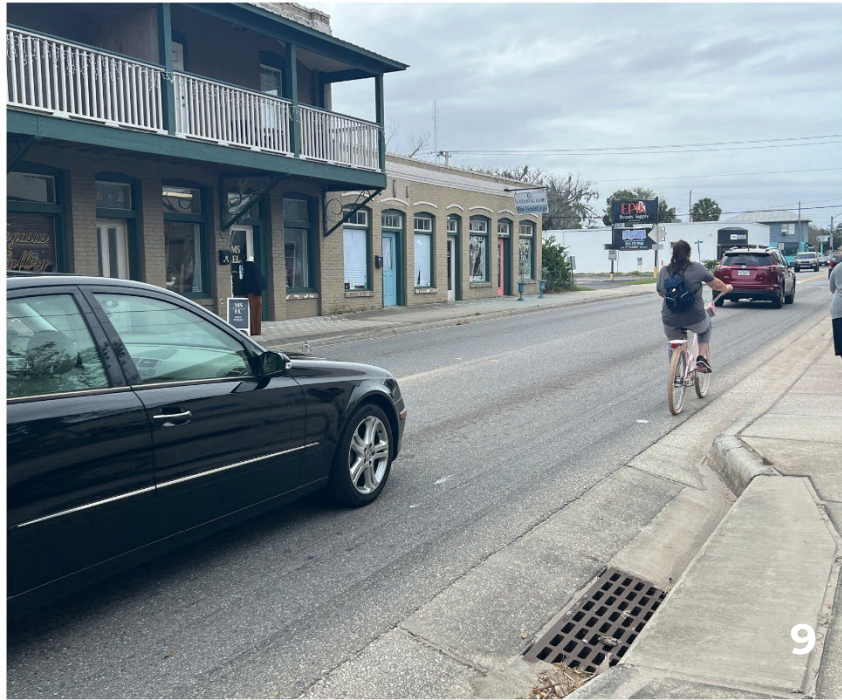
Defective or inadequate transportation infrastructure is determined by the size and arrangement of transportation infrastructure and supporting facilities, including pedestrian and public transit infrastructure. Parking facilities are in short supply in the Study Area, which impacts the ability of residents and visitors to visit local businesses or institutions. Pedestrian infrastructure is also lacking. West King Street is a busy thoroughfare connecting western St. Johns County to St. Augustine's downtown core. There is insufficient pedestrian and biking infrastructure to protect residents and visitors from vehicles. Many people bike through the Study Area, particularly along West King Street into historic Downtown St. Augustine, yet there is very little biking infrastructure. Cyclists must hug the shoulder of a busy road to be able to reach their destinations. Many roads do not have marked or signalized pedestrian crossings. When sidewalks are present, they tend to be in disrepair or have accessibility challenges, as can be seen in the images on the next page. Where pedestrian and biking infrastructure exists, it is inadequate to the number and speed of vehicles moving through the commercial corridor. The observed defective transportation facilities within the Study Area satisfy the definition for a condition of "blight."

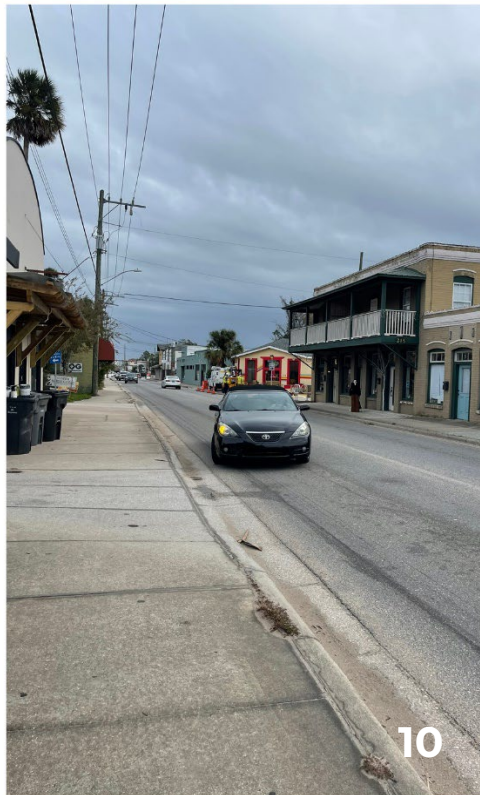
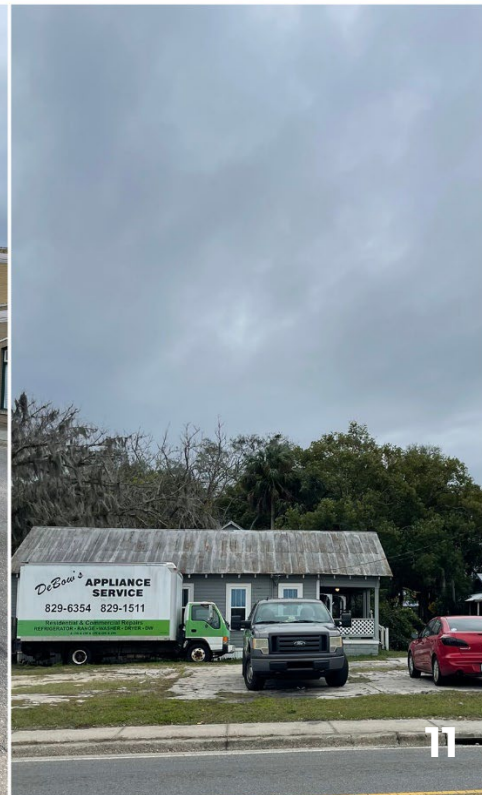
Lot layouts are classified as faulty if their sizes, adequacy, accessibility from roadways, or usefulness serve as a deterrent to successful redevelopment activity. Accessibility of lots is the primary challenge identified within the Study Area, specifically regarding commercial lots along major corridors. Commercial lots in the Study Area generally have small parking lots in the front of the building which are challenging to navigate, and over time this condition may impact consumers' willingness to visit certain businesses.

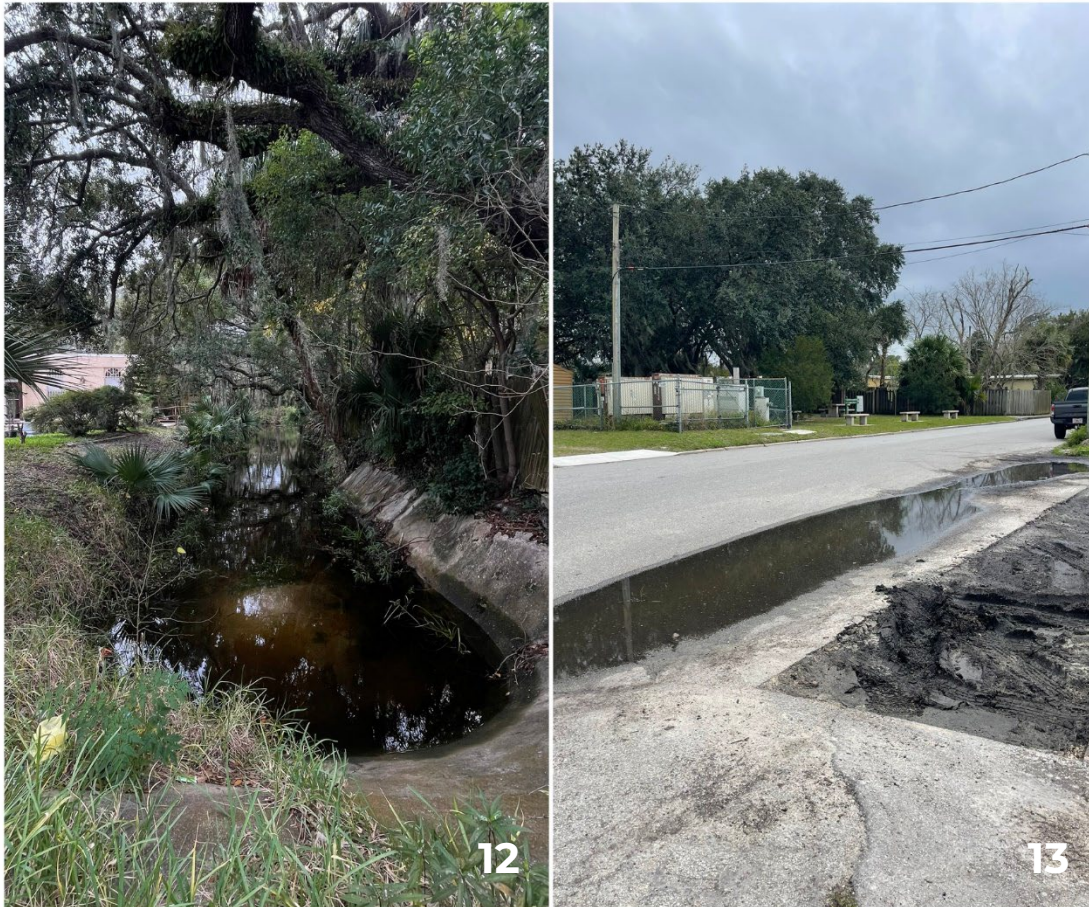
Some infrastructure in the Study Area causes unsafe and unsanitary conditions. Roadways are in differing states of repair, some with cracked asphalt and potholes. Parking lots and sidewalks have large potholes and cracks, as well. These conditions are unsafe for pedestrians, as well as vehicles. Stormwater infrastructure is also creating unsafe and unsanitary conditions with flooding and standing water which can provide ample breeding grounds for mosquitos, other insects, and the diseases they can carry. Standing water can also create fall risks which can result in drowning, especially for children.

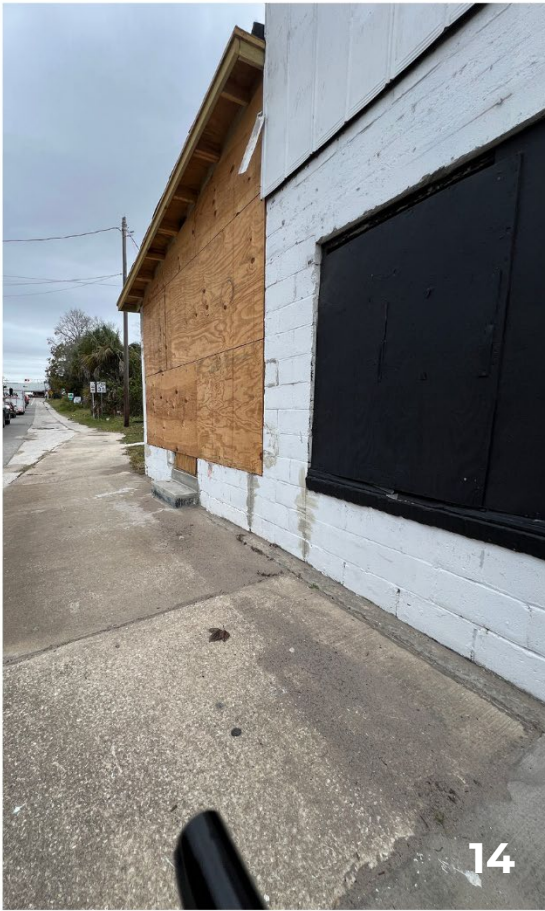
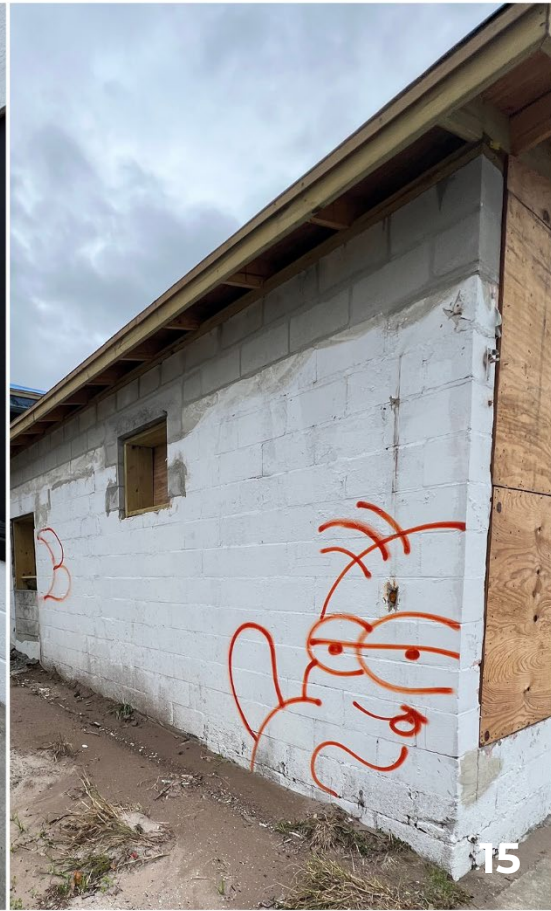
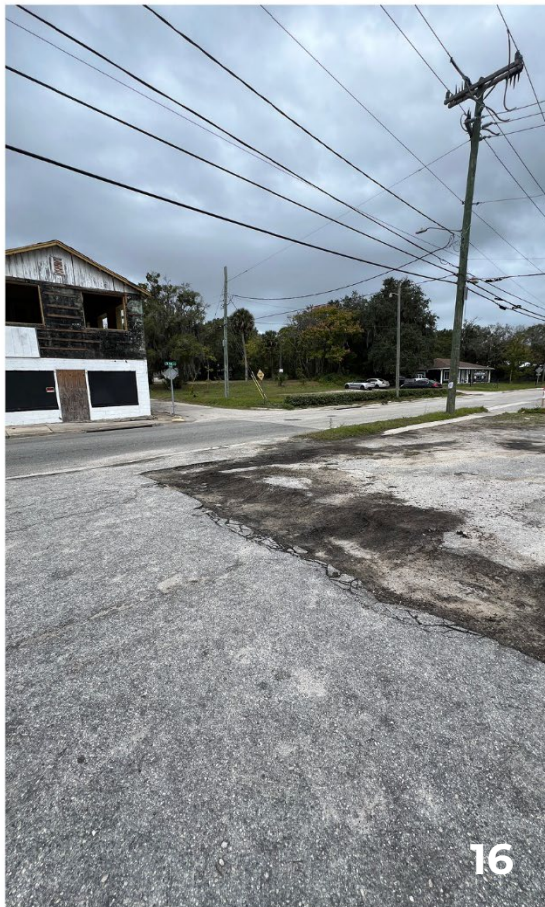
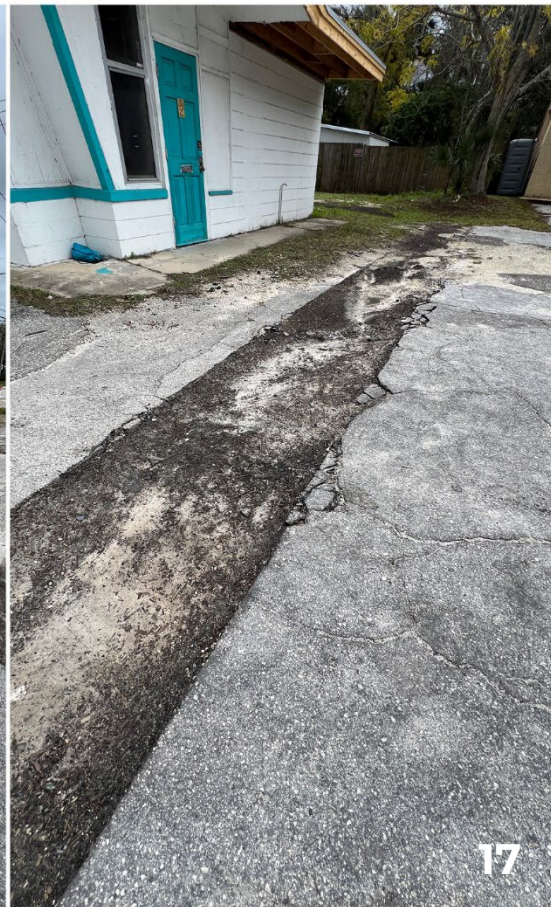
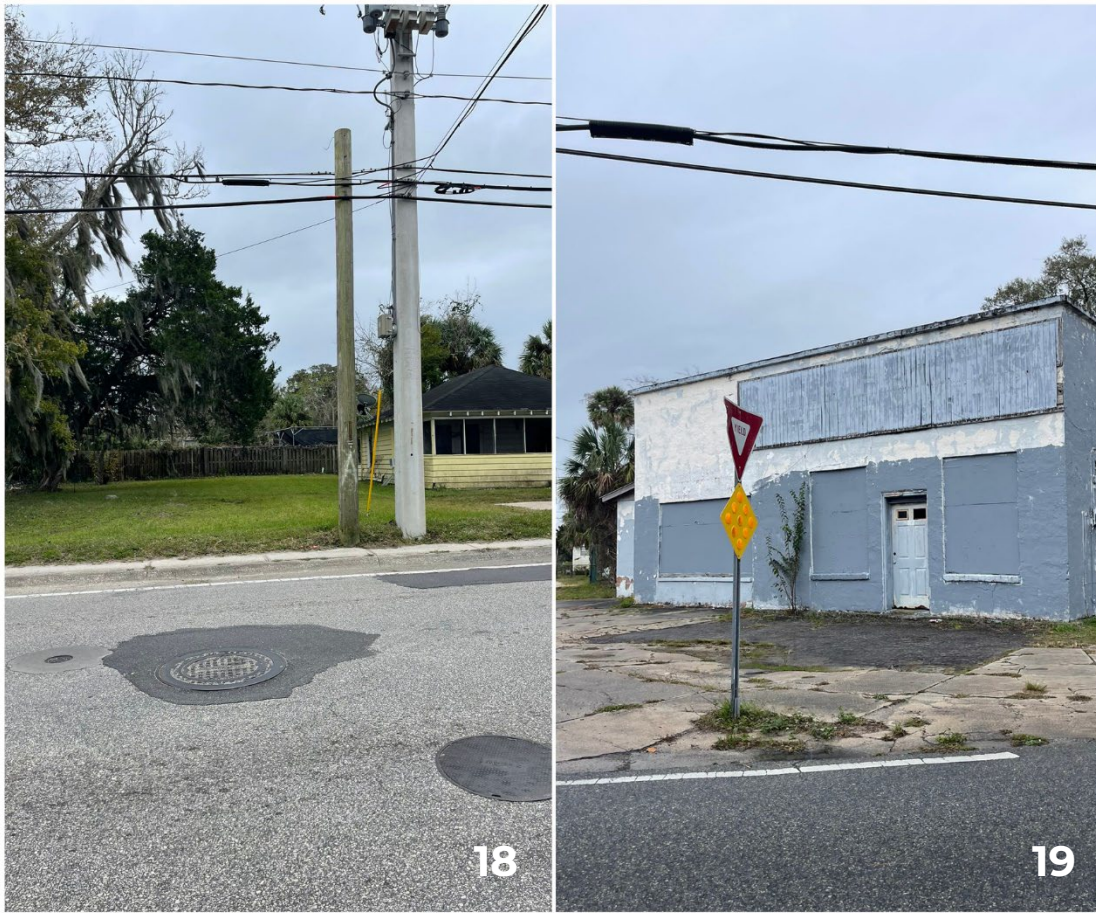
The deterioration of site or other improvements is primarily determined by the physical conditions of buildings or site improvements, including their evaluated useful lives. Several commercial sites within the Study Area have been left to deteriorate and are either abandoned or waiting to be sold or leased. Buildings have graffiti and boarded windows and doors. Residential structures, as observed during the field study, have damaged roofs, dilapidated structural elements, and other signs of lacking maintenance. The deterioration is also seen in parking lots, sidewalks, and roadways. Roadways have potholes and cracks, and the shoulders of the roads have vegetation growing throughout. Sidewalks are broken, uneven, and have large holes in them. Parking lots at commercial sites have large missing pieces of asphalt and cracks. These conditions impact the perception of the Study Area and may prevent business owners or potential residents from choosing to locate in the area. The observed deterioration of sites or other improvements within the Study Area satisfy the definition of a blighted condition.
